Analysis of compressor valves bolts failure

S. Budimir, A. Alil, M. Ristic, M. Kocic and B. Katavic

Institute Goša, Belgrade, Serbia
E-mail: stevan.budimir@institutgosa.rs

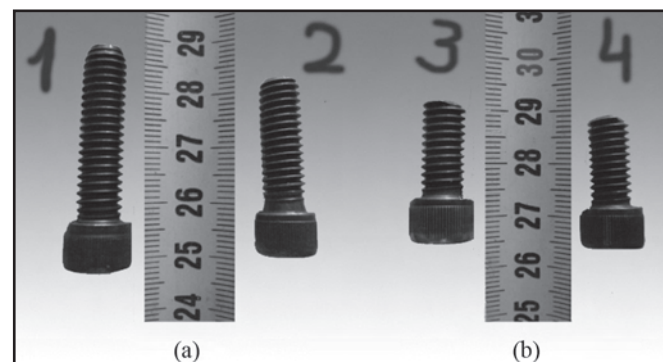
Figure 1. As-received used unbroken (a) and broken (b) bolts from compressor valve.

Visual examination of used unbroken bolts hasn't shown any irregularities presence. Broken bolts were deposit-coated. The color of deposit was predominantly black. The light-gray and brown-red areas (probably the result of oxidation in ambient air) were occasionally observed mixed with black deposit. Generally, all bolts had a complex topography of fractured surfaces. Common for all bolts was that the fracture was initiated at the thread roots. After initiation, cracks propagated through the stud in radial direction, sometimes abruptly changing the planes of propagation to the final fracture. Radiography measurements have shown that all broken bolts had mechanical damages in the stud. The measurements of used unbroken bolts didn't reveal any presence of defects / imperfections / discontinuities.

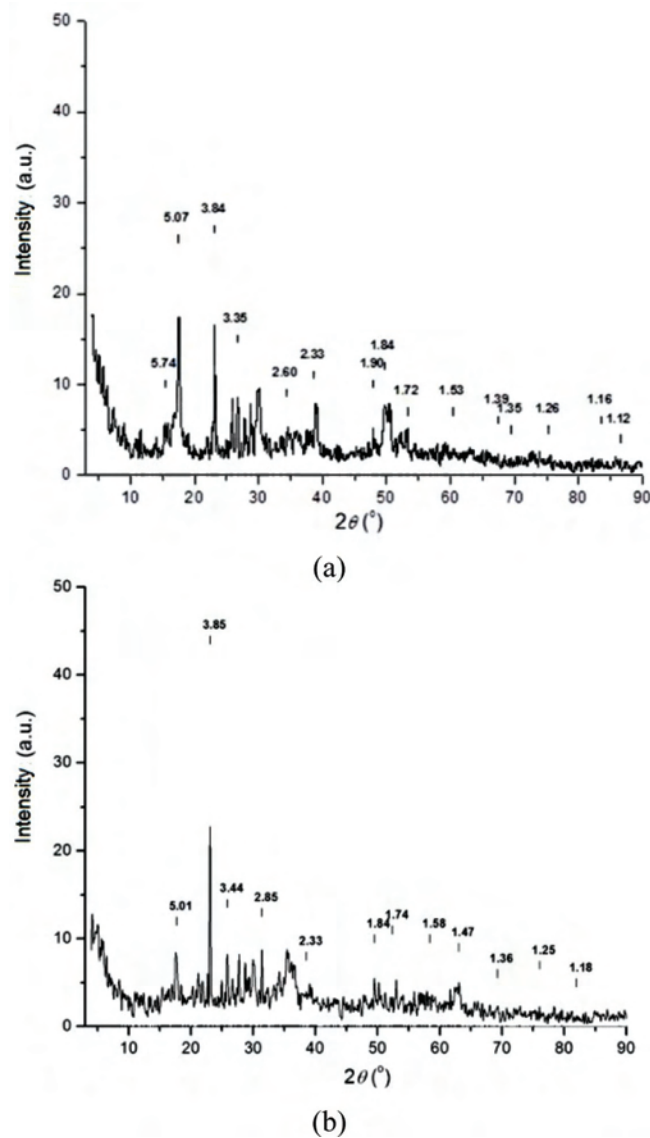
Using XRPD analyze the presence of corrosion products is detected, which are very poorly crystallized and which occur in corrosion environments where H₂S is present. These are iron sulfides (FeS-makinawite, Fe₃S₄-centered cubic iron sulfide and Fe₃O₄-magnetite) and elementary sulfur S₈. In the case of

deposits obtained from used unbroken bolts (Figure 2a) only two crystalline phases are equally represented: iron sulfide, makinawite, Fe_{1+x}S, x = 0.057-0.064, (JCPDS 89-2738), and less present crystalline phase is sulfur, S₈ (JCPDS 83-2283). Makinawite is the layered sulfide, nonstoichiometric compound. Sulphur occurs as α -S, the most common rhombic allotropic modification, which was built by eight ring of sulfur

Figure 2. X-ray diffraction patterns of deposits from compressor valve: (a) diffraction pattern corresponds to mixture of deposit powders taken from used unbroken bolts; (b) diffraction patterns correspond to deposit powders taken from different as-received broken bolts.

atoms, and therefore it is marked as S₈. The most common corrosion phase (about 60%) is elemental sulfur, S₈ in the case of deposits obtained from broken bolts (Figure 2b) (JCPDS 83-2283). The other crystalline phases are presented each by approximately 20%. These are makinawite and iron oxide, magnetite, Fe₃O₄, (JCPDS 19-0629). Reflections of magnetite are very broad and poorly defined. There is a possibility that some magnetite transferred to iron oxide hydroxide goethite α -FeO(OH) (JCPDS 29-0713), but this can not be said with certainty. SEM-EDS analysis of the deposit is made in the peripheral parts of the bolts in order to determine

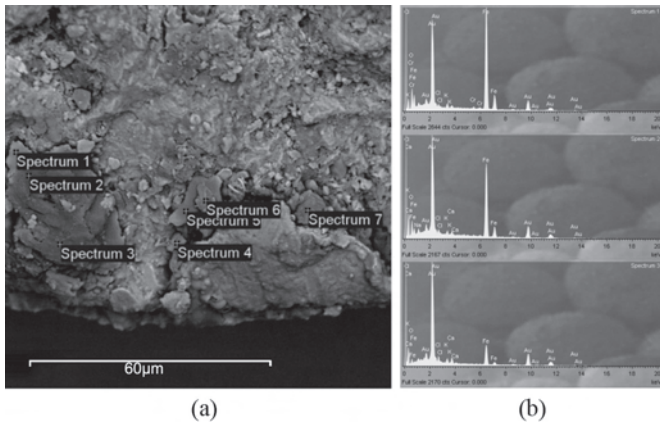
Figure 3. (a) Fracture surface of broken bolt SEM image, (b) EDS spectrums of corrosion products.

an increase in the presence of sulfur, oxygen, chlorine, calcium and potassium. Appearance spectrum with detected sulfur is similar to EDS spectrum obtained in the analysis of fracture surfaces of broken bolts. This suggests a possible link between the process of corrosion and fracture of bolt materials during operation. Additionally, the presence of oxygen were detected in all cases where the sulphur was found.

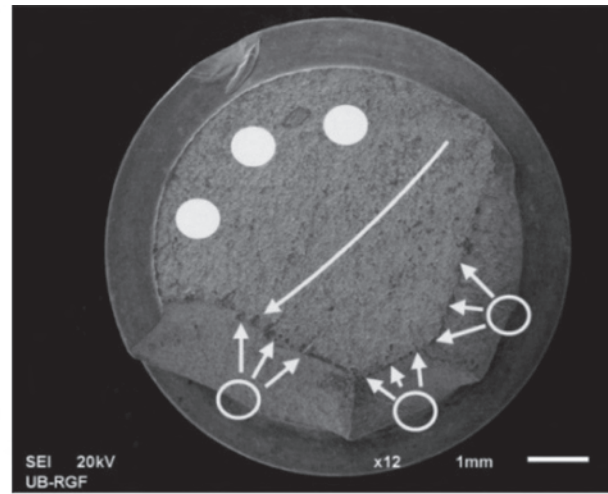
(a)

Figure 4. Fractography analysis of the broken bolt. (a), (b) the central zone. Surfaces were covered with gold coating (thickness of about 20 nm), scanning electron microscope (SEM) image of secondary electrons.

In Figure 4 are given the representative results of fractography analysis. The crack initiation sites analysis is mostly performed on used unbroken and on broken bolts. In this analysis, the used unbroken bolts are observed as candidates that should fail by fracture during their service but didn't. Therefore, in this case, there was a high probability to detect corrosion products that didn't develop into cracks or cracks that have been initiated at thread root sites that didn't grow to a critical size for final fracture to happen. Fracture surfaces of broken bolts shown in Figure 4 indicate that the effect of complex fractures incurred operating conditions (stresses and corrosive environments). Most of the fracture surface is checkmated, indicating the predominant character of ductile fracture. In all cases the initiation of fracture is created in the root of the bolt and in multiple locations, as shown in the open circles (o). Straight arrow indicates the direction of movement of cracks and fracture

mechanism of brittle quasi-cleavage. Parts of the fracture surface indicating the final fracture are shown by full circles (●). These flat parts of the fracture surface indicate brittle fracture. The fracture micro-mechanism wasn't determined because of the presence of this surface layer, which was created during the operation of bolts
